**KOMITE NASIONAL KESELAMATAN TRANSPORTASI
REPUBLIC OF INDONESIA**

KNKT.18.10.35.04

Aircraft Accident Investigation Report

**PT. Lion Mentari Airlines
Boeing 737-8 (MAX); PK-LQP
Tanjung Karawang, West Java
Republic of Indonesia
29 October 2018**

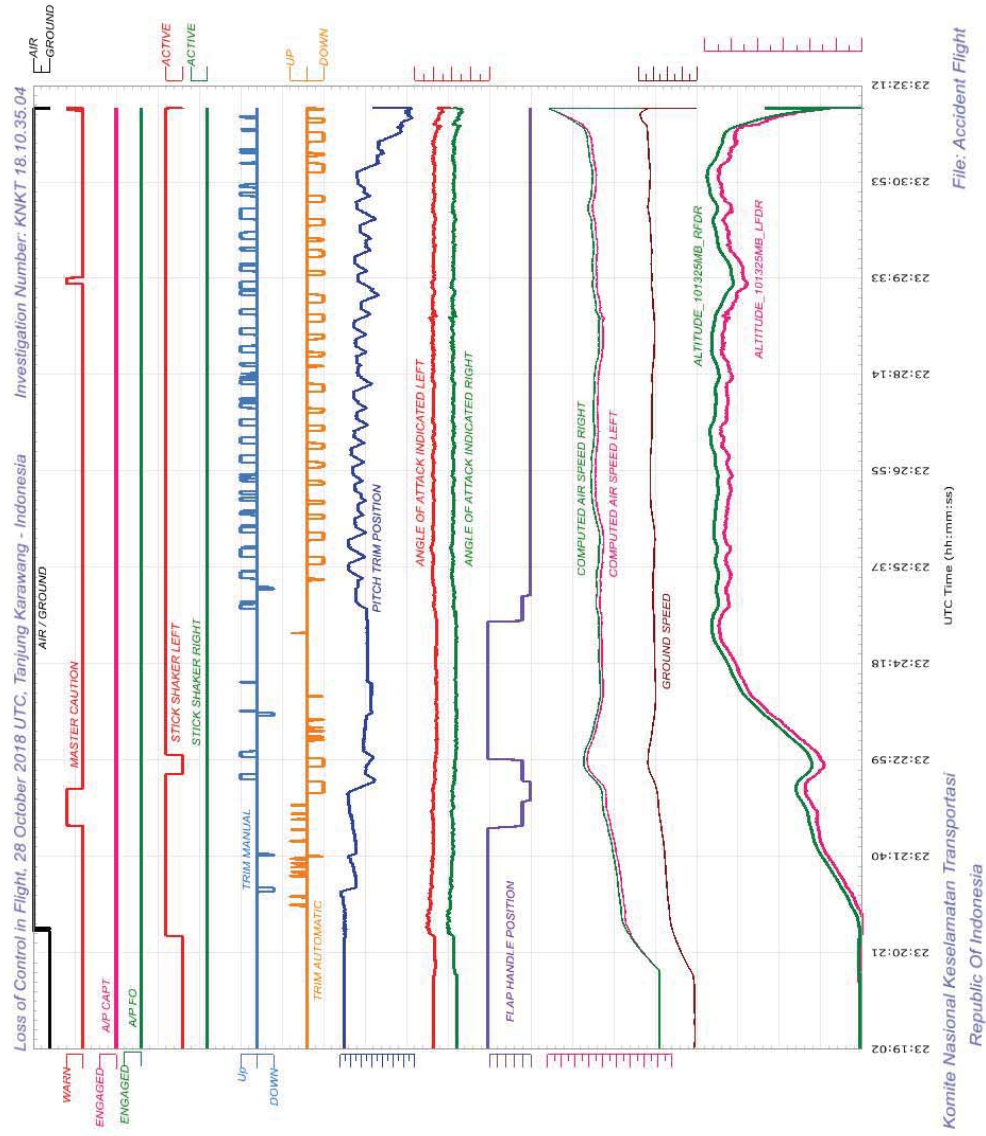
Figure 5: The significant parameters from the accident flight

Several significant parameters of the DFDR are shown on the following figures.

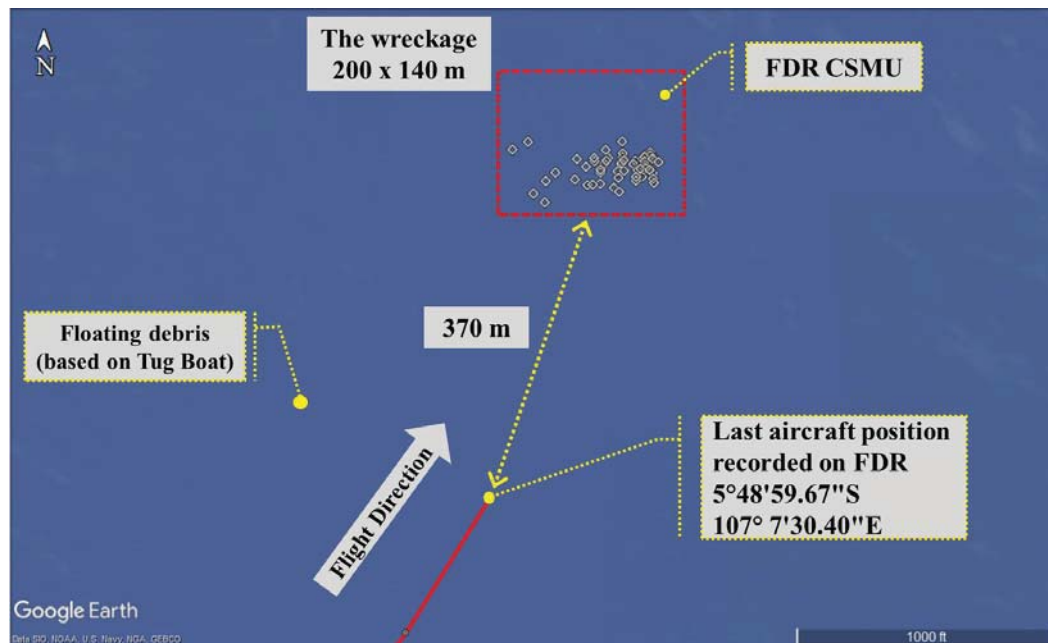
Figure 8: The wreckage distribution

The damage to the aircraft suggested a high energy impact.
